TITLE: HDPE PIPE - LARGE CATCH BASIN (30"-48")		REV: A
DRAWN BY: TRA	DATE: 10-Sep-18	DRAWING NUMBER:
SCALE: NTS	SHEET: 1 OF 1	D-1-106

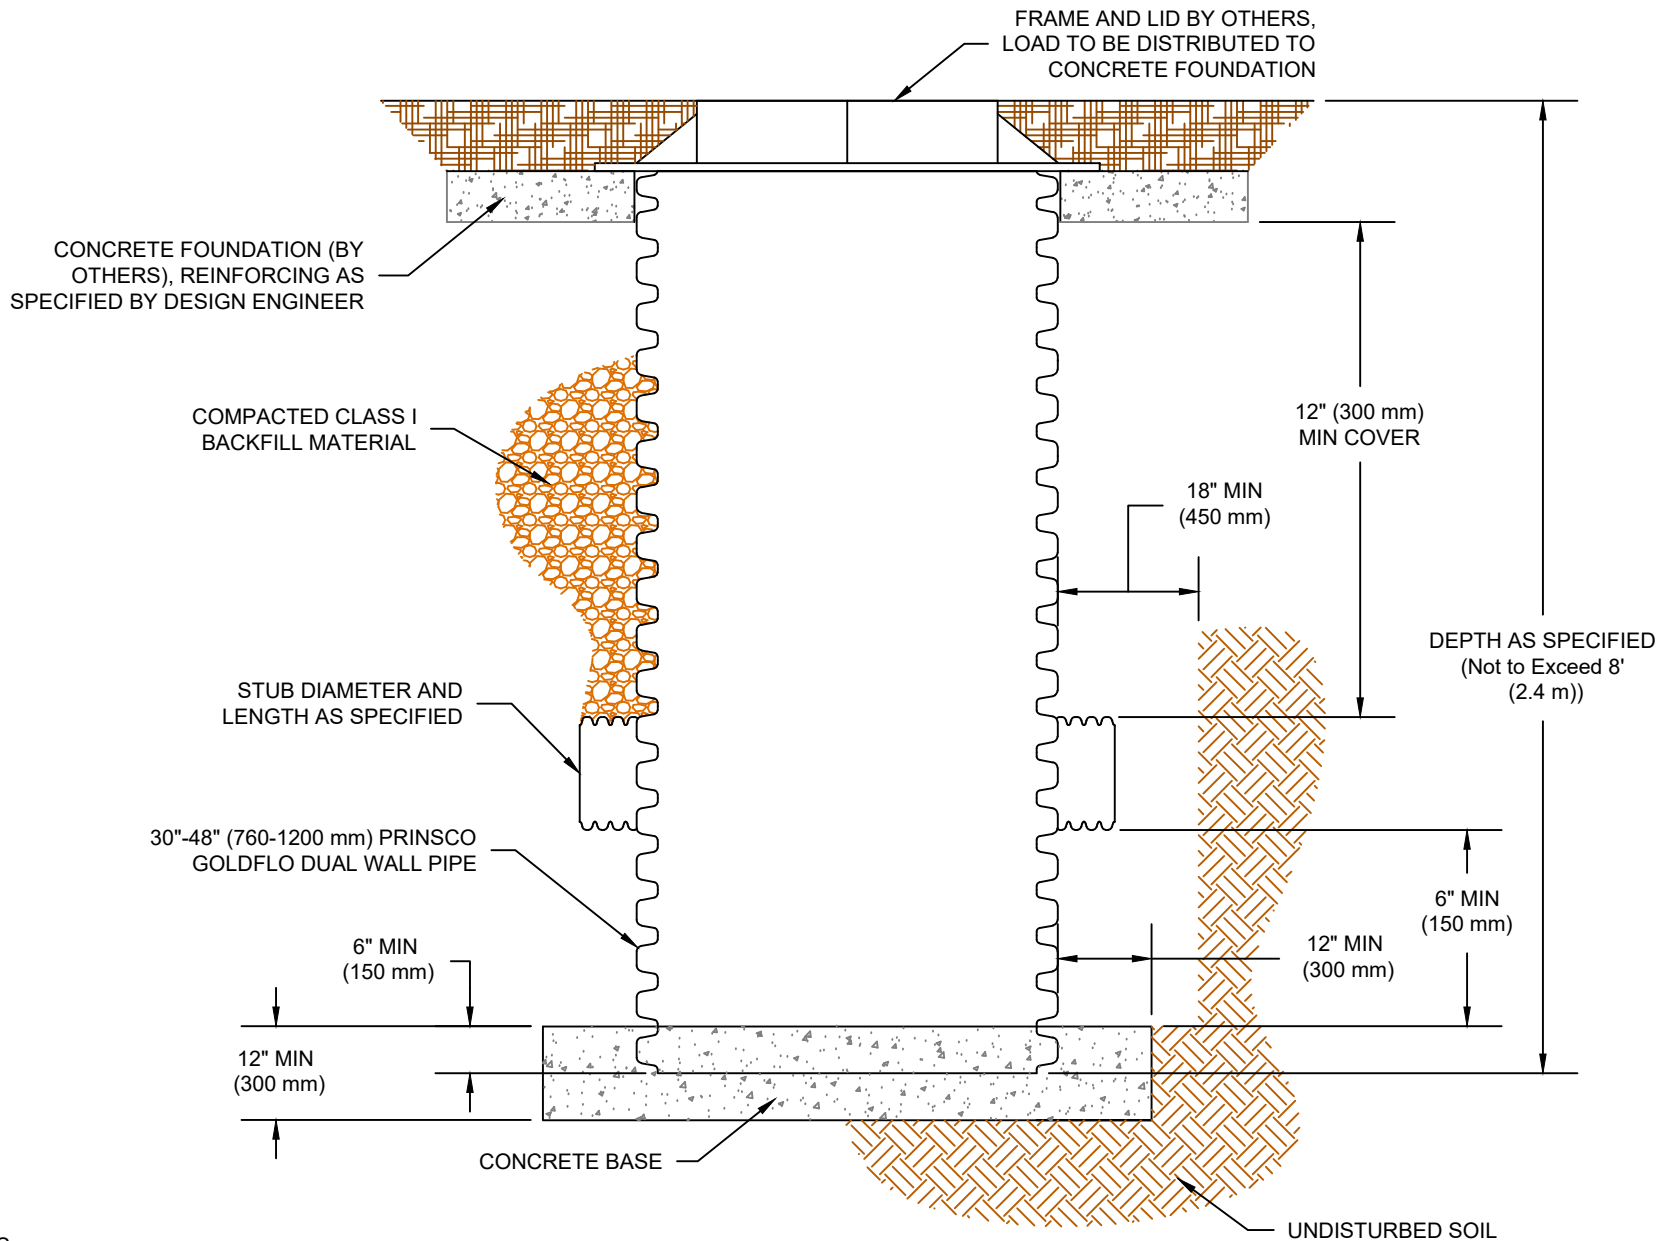
- PROPER BACKFILL AND INSTALLATION OF CORRUGATED HDPE PIPE IN VERTICAL APPLICATIONS IS CRITICAL FOR LONG-TERM PERFORMANCE. IF BACKFILL IS NOT PROPERLY PLACED OR COMPACTED, SOIL CONSOLIDATION MAY CAUSE THE BASIN TO SHRINK IN HEIGHT AND CAUSE DAMAGE OR DISTRESS TO THE HDPE RISER. THE TALLER THE RISER, THE GREATER THE RISK OF DAMAGE. THE MAXIMUM RECOMMENDED HEIGHT FOR VERTICAL STRUCTURES IS 8'.
