| TITLE:<br>HDPE PIPE - AGRICULTURAL CATCH BASIN INSTALLATION | | | |
| | | DRAWING NUMBER:<br>D-1-114 | |

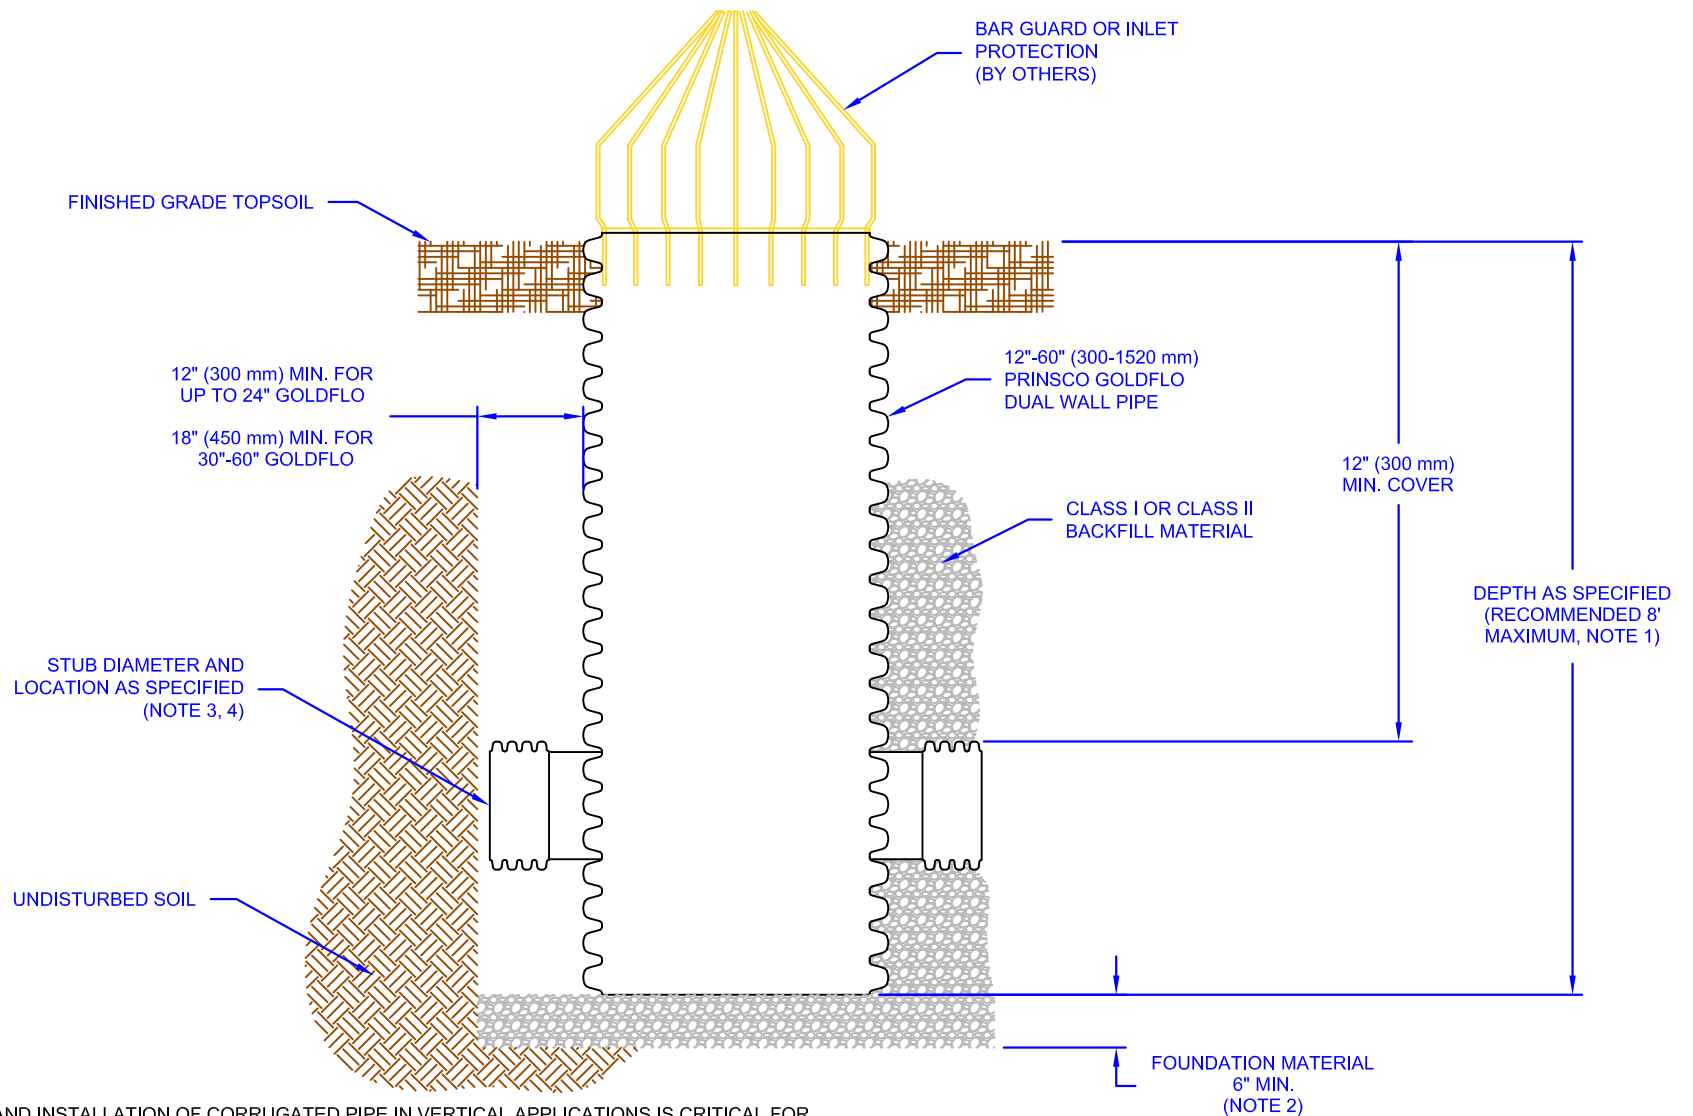
1. PROPER BACKFILL AND INSTALLATION OF CORRUGATED PIPE IN VERTICAL APPLICATIONS IS CRITICAL FOR LONG-TERM PERFORMANCE. IF BACKFILL IS NOT PROPERLY PLACED OR COMPACTED, SOIL CONSOLIDATION MAY CAUSE THE BASIN TO SHRINK IN HEIGHT AND CAUSE DAMAGE OR DISTRESS. THE TALLER THE RISER, THE GREATER THE RISK OF DAMAGE. CONTACT YOUR PRINSCO REPRESENTATIVE FOR BURIAL DEPTHS GREATER THAN 8'.
2. DEPENDING ON SOIL CONDITIONS, SUITABLE FOUNDATIONS CAN BE CLASS I OR CLASS II BACKFILL, OR A CONCRETE BASE.
3. COMPACT BACKFILL BENEATH STUBS TO ENSURE PROPER SUPPORT AND PREVENT DIFFERENTIAL SETTLING.
4. STUBS CAN COME FABRICATED ON THE BASIN OR CAN BE INSTALLED IN-FIELD WITH A CORED HOLE AND EZ-TEE ASSEMBLY.
